Step 3: Current Conditions

Soil Resources

Current Conditions - Erosion Processes

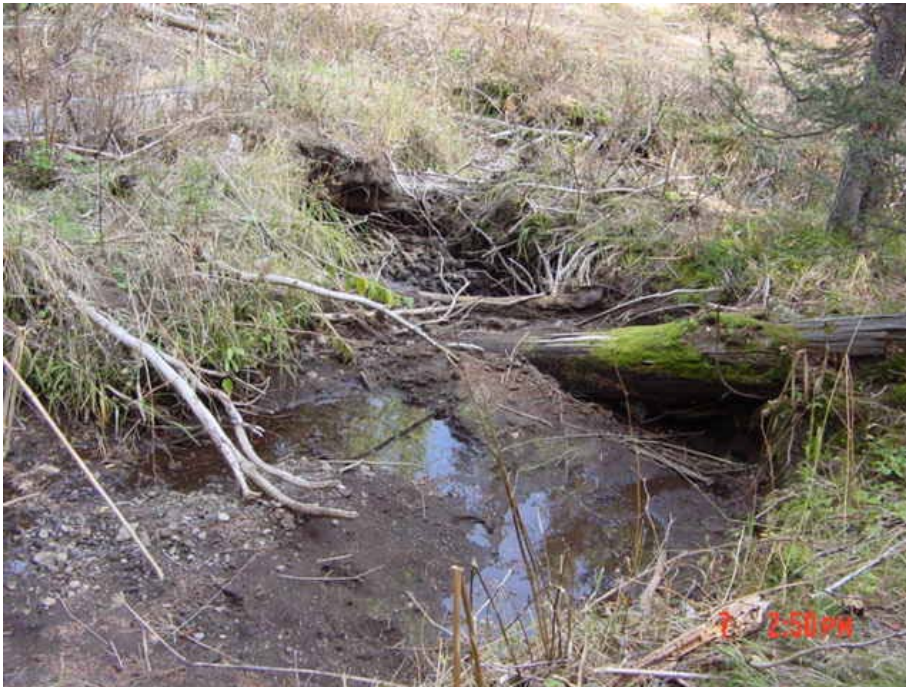
Figure 70 About ½ mile below FDR 048, the stream disappears into the subsurface and the stream is dry until the Arange Creek confluence, about 2 miles downstream.

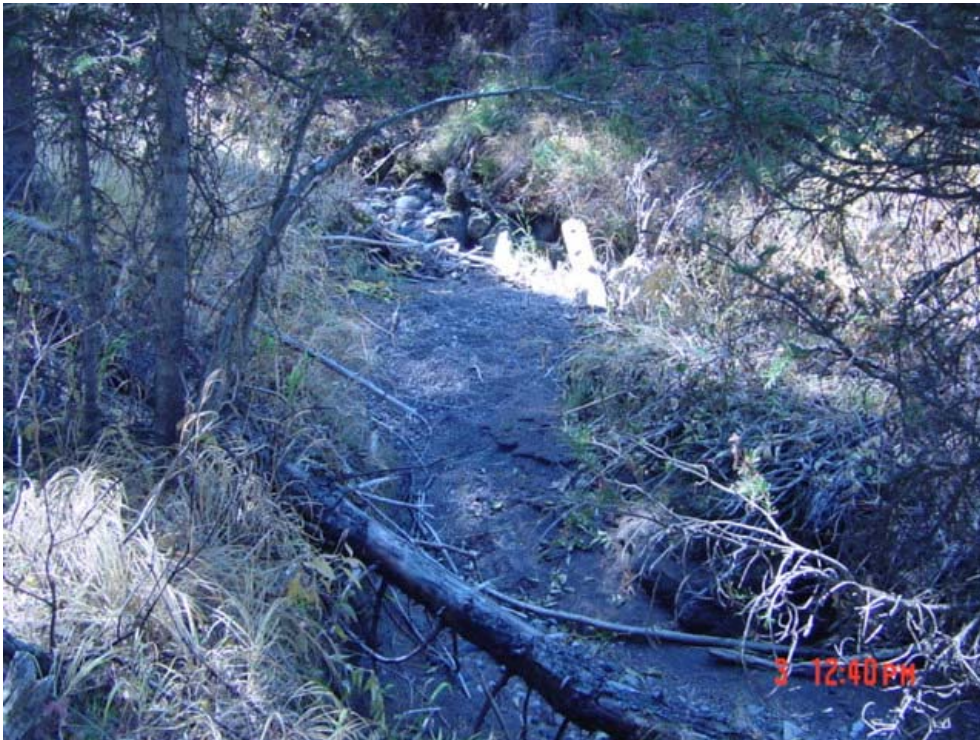
Figure 71 West Fork at the Arange Creek confluence. The channel is dry with an extremely heavy sand bedload. Perennial flows of Arange Creek have scoured sand from the channel.

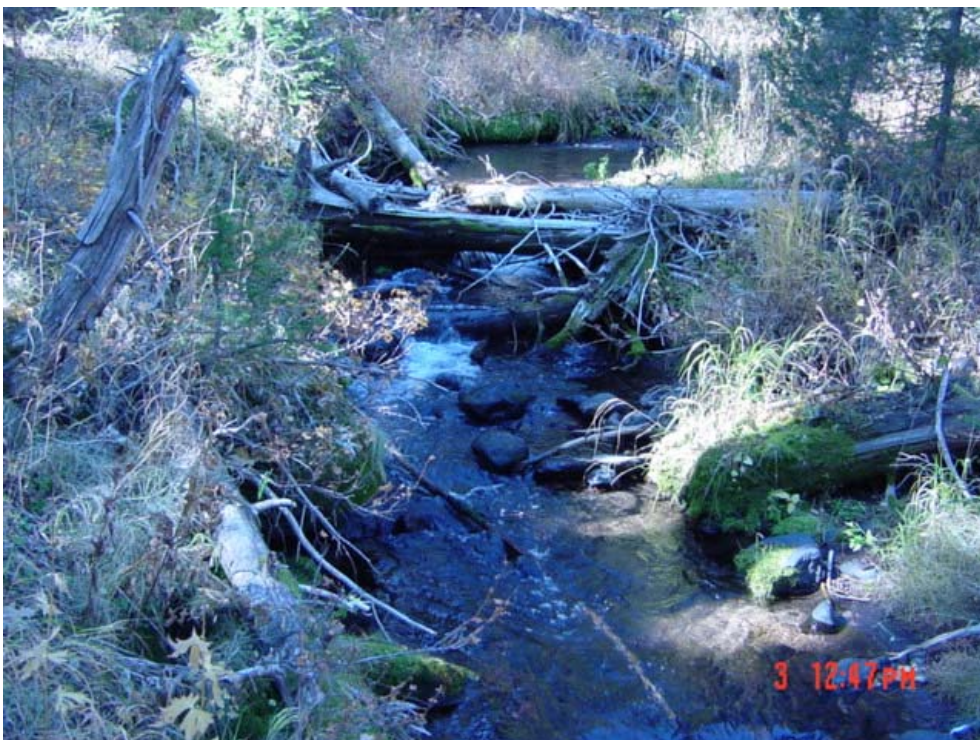
Figure 72 West Fork just below the Arange Creek confluence. Flow ~ 2-3 cfs. Heavy sand bedload.
